Net Environmental Benefit of Ft. Pierce Marina and Storm Protection Islands Project

City of Fort Pierce

Tetra Tech, Inc

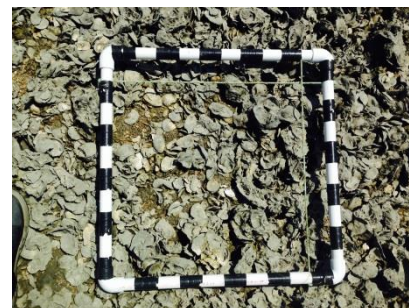
Haphazardly placed Vexar® mats (18 inches square in size with thirty-six (36) high shell fraction cochina fragments attached to each mat) were secured at the sampling locations throughout the selected constructed islands. The monitoring design came from a study conducted by Lisa Wall titled, "Recruitment and Restoration of the oyster, *Crassostrea virginica*, in Areas with Intense Boating Activity in Mosquito Lagoon, Florida in 2001."

Thirteen (13) mats were sampled along both the protected and exposed sides of Tern Island and 1 or 2 two mats each for freeform islands with created oyster habitat (Fishhook, Snook, Starfish, and Manatee) for a total of 19 monitoring stations. The mats were removed in order to count the number of recruited oysters during monitoring. Once removed, the live oysters on each substrate shell were counted and the mats were subsequently returned to their original sampling locations. Photographic and written documentation of each mat were collected and will be used to track oyster recruitment and abundance over extended periods. All collected data was utilized to find the number of spat or live oysters per recruitment mat and per meter square. An average was taken for the number of species found per meter squared area.
